PRELIMINARY REPORT ON ACCIDENT INVOLVING SIKORSKY S-76C+ HELICOPTER BELONGING TO BRISTOW HELICOPTERS NIGERIA LIMITED WITH REGISTRATION 5N-BGD WHICH OCCURED AT OWORONSHOKI AREA OF LAGOS ON THE 12<sup>TH</sup> OF AUGUST, 2015.

REGISTERED OWNER AND OPERATOR: Bristow Helicopters Nig. Ltd.  
PLACE OF ACCIDENT: Oworonshoki, Lagos.  
DATE AND TIME: 12<sup>TH</sup> of August, 2015 at about 1531hrs.  
LOCATION: Oworonshoki area of Lagos. Lat: 6<sup>0</sup> 31' 54" N and Long: 3<sup>0</sup> 26' 16" E.  
(All times in this report are local time, equivalent to UTC+1, unless otherwise stated)

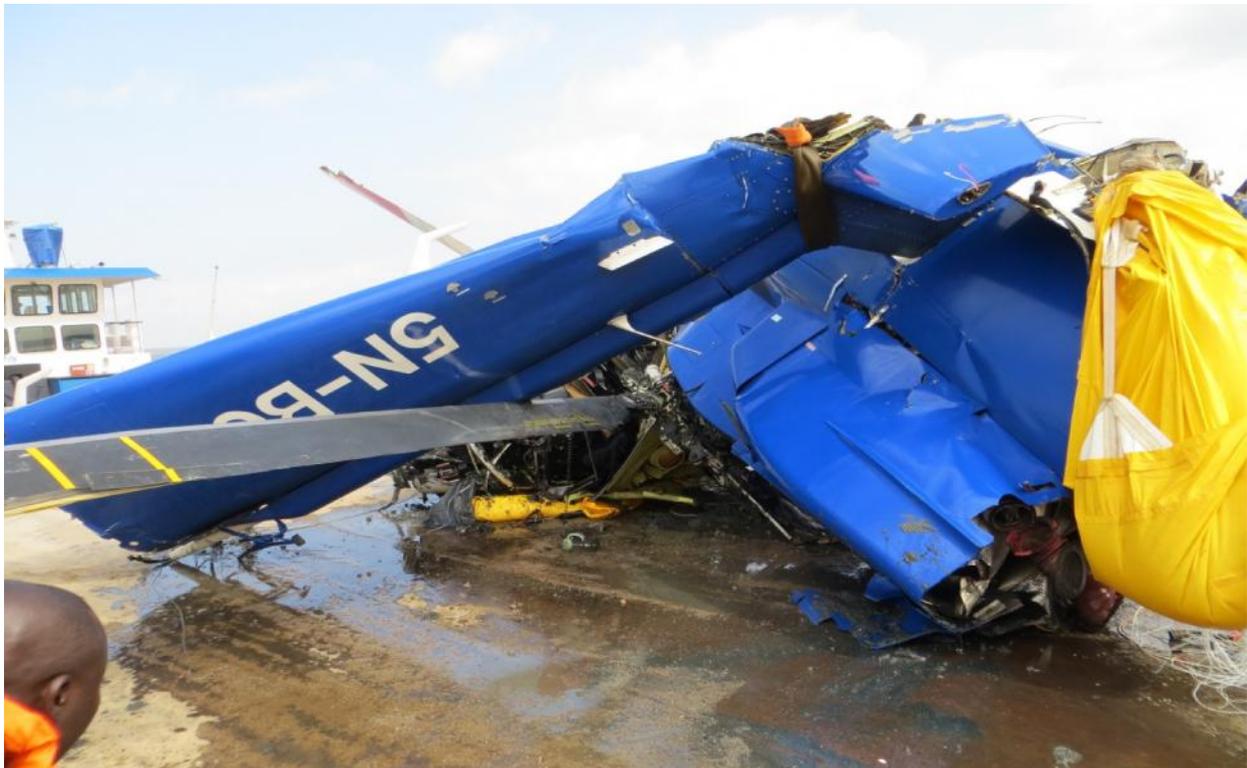
The helicopter was destroyed by impact forces with water.

Fig. 1 Part of the destroyed Helicopter.

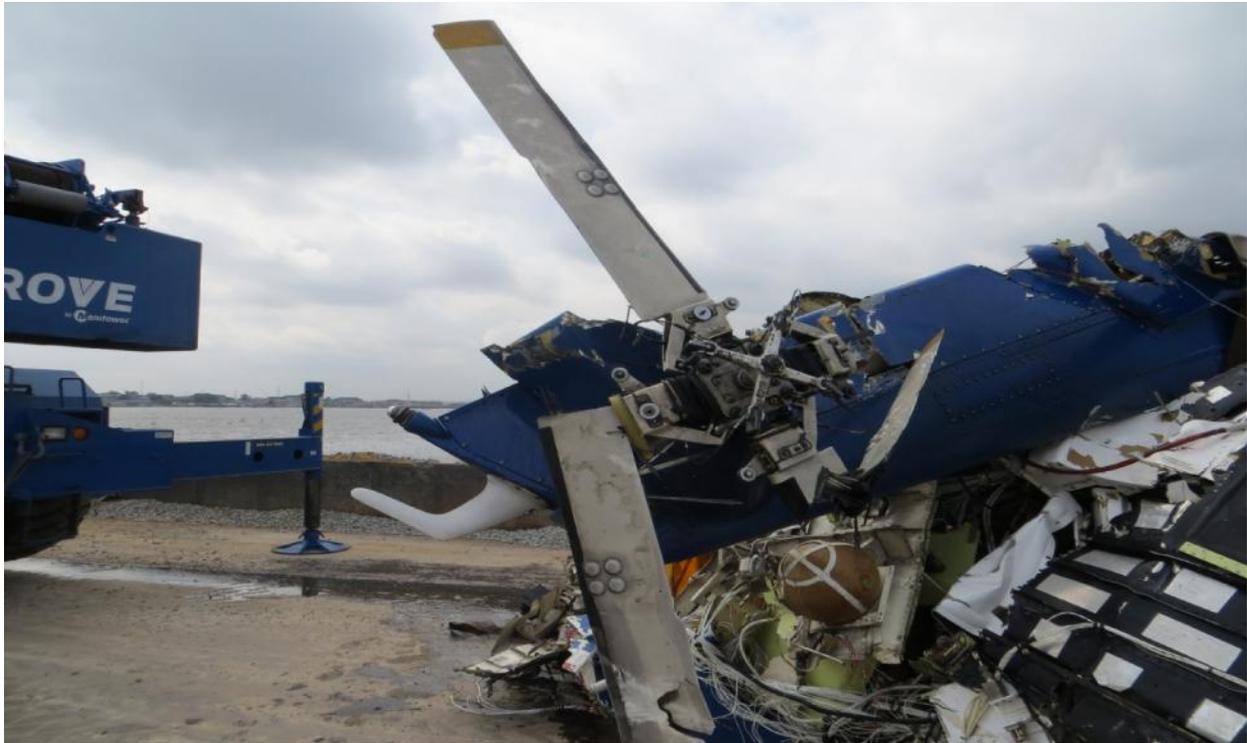
Fig. 2 Part of the destroyed tail Rotor area.

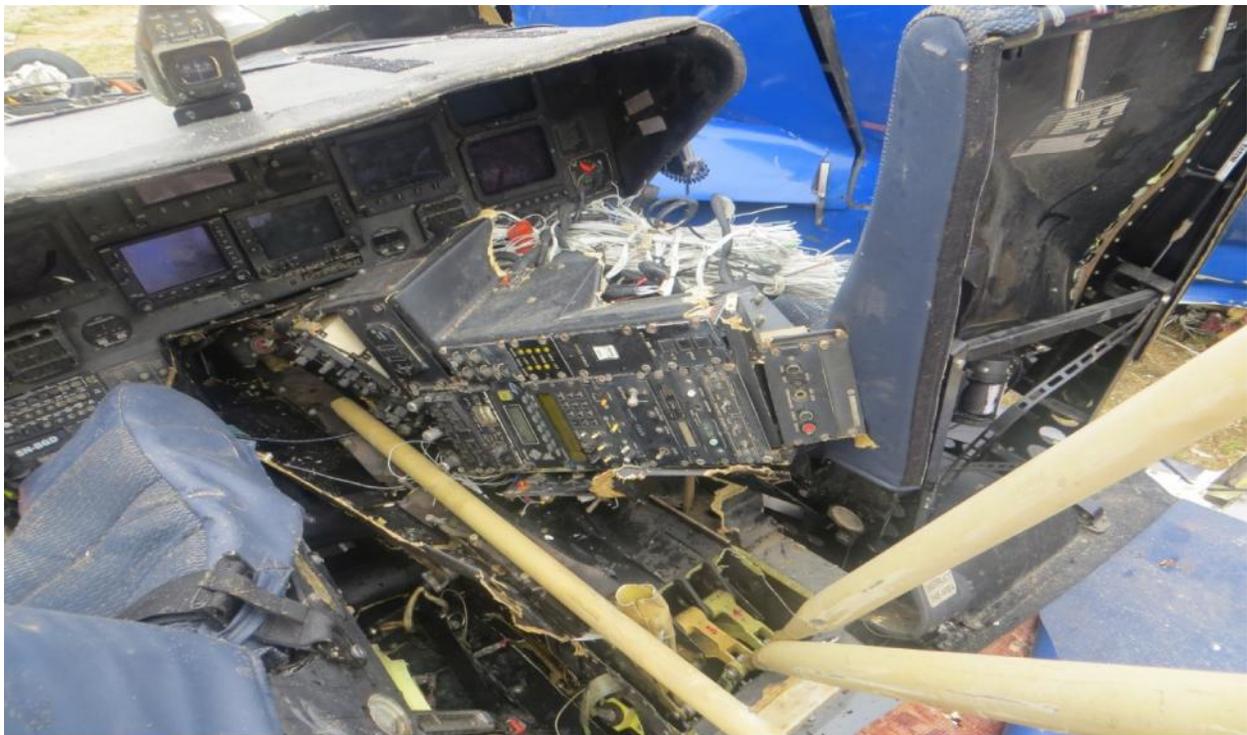
Fig. 3 The cockpit area of the wreckage.

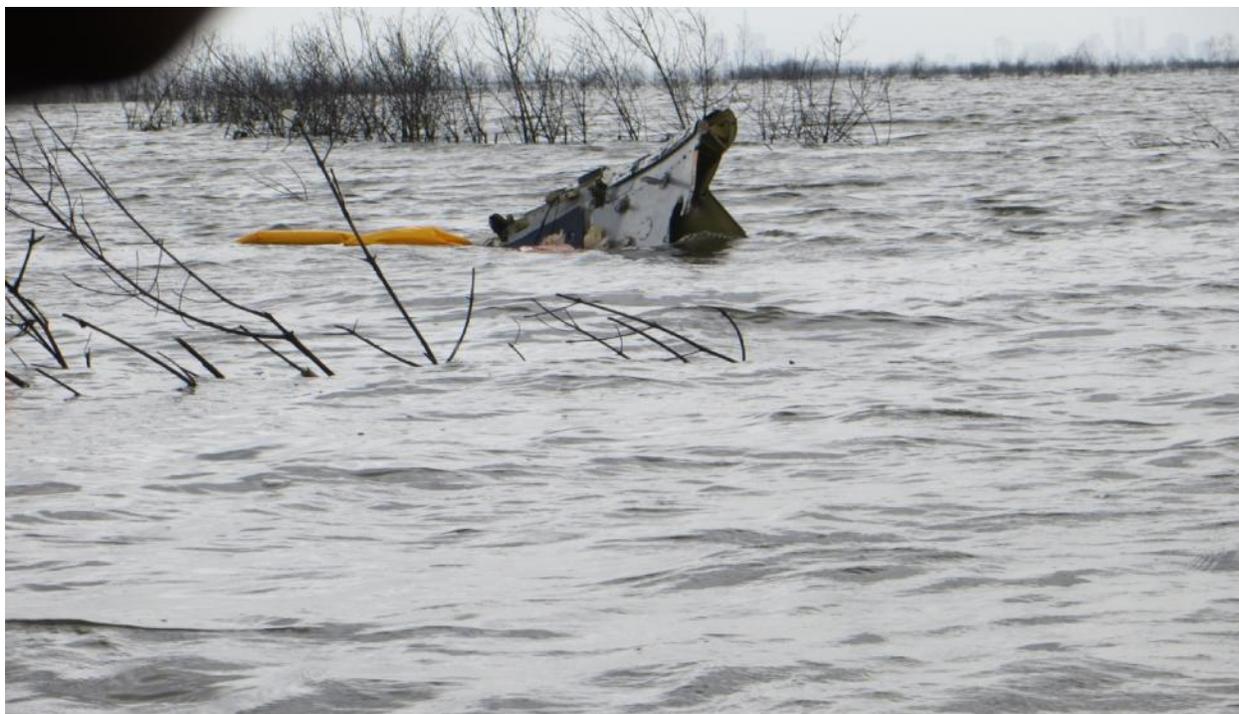
Fig. 4 The crash site.

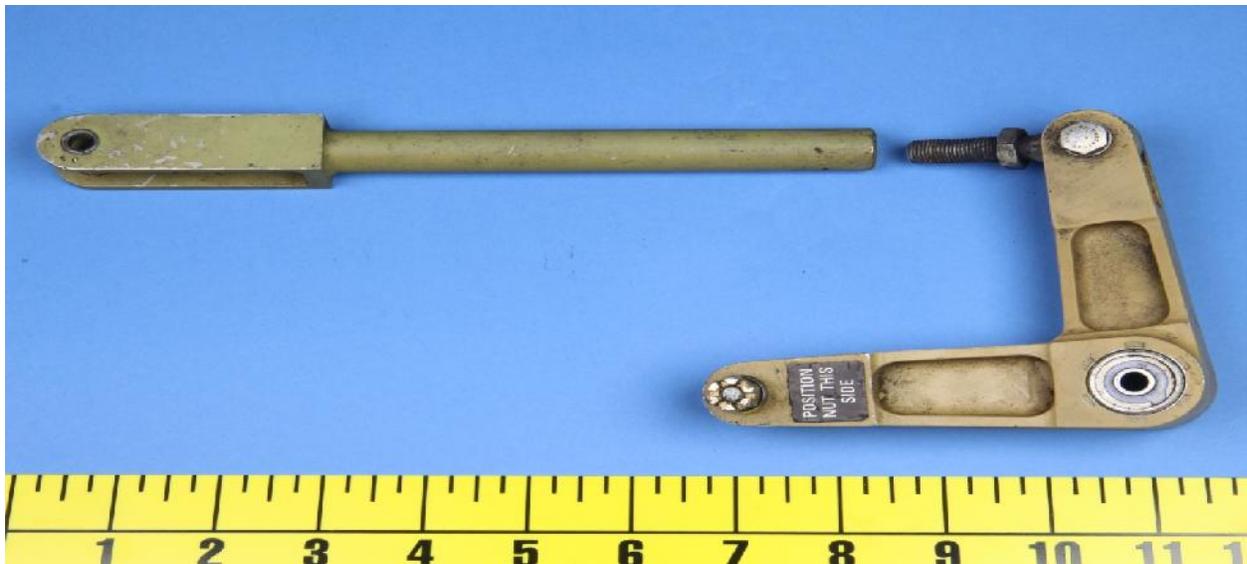
During the preliminary investigation AIB discovered that the Forward Main Servo Input Control Pushrod Assembly had failed. The Control Pushrod tube separated from Control rod end with the bearing and the Jamnut. The Jamnut was loose and was not seating against the Control Rod. See Figures 8 and 9.

National Transportation Safety Board (NTSB) Laboratory preliminary metallurgical examination of the Forward Main Rotor Servo Input Control Pushrod revealed that the separation was a pre-impact condition

Fig. 8 Control Pushrod and Control Rod end with bearing and Jamnut

14. No records of any deferred defects in the tech log.
15. The Control Pushrod tube separated from Control rod end with the bearing and the Jamnut. The Jamnut was loose and was not seating against the Control Rod.

Accident Investigation Bureau considers the ASB and EAD as interim actions which define an unsafe condition. The failure of the pushrod assembly could result in loss of main rotor or tail rotor flight control and consequent loss of control of the helicopter.

Purpose: "To perform a onetime inspection of installed Forward, Aft and Lateral Main Servo Input Control Pushrod s and Jamnuts and Tail Servo Input Control Pushrods and Jamnuts for proper installation, condition and security followed by application of slippage mark on all Main and Tail Servo Input Control Pushrod Jamnuts".

Sikorsky Aircraft Corporation should consider a redesign of the affected control pushrod assembly by introducing additional wire locking safety features between the Jamnut and the Pushrod to enhance better security.

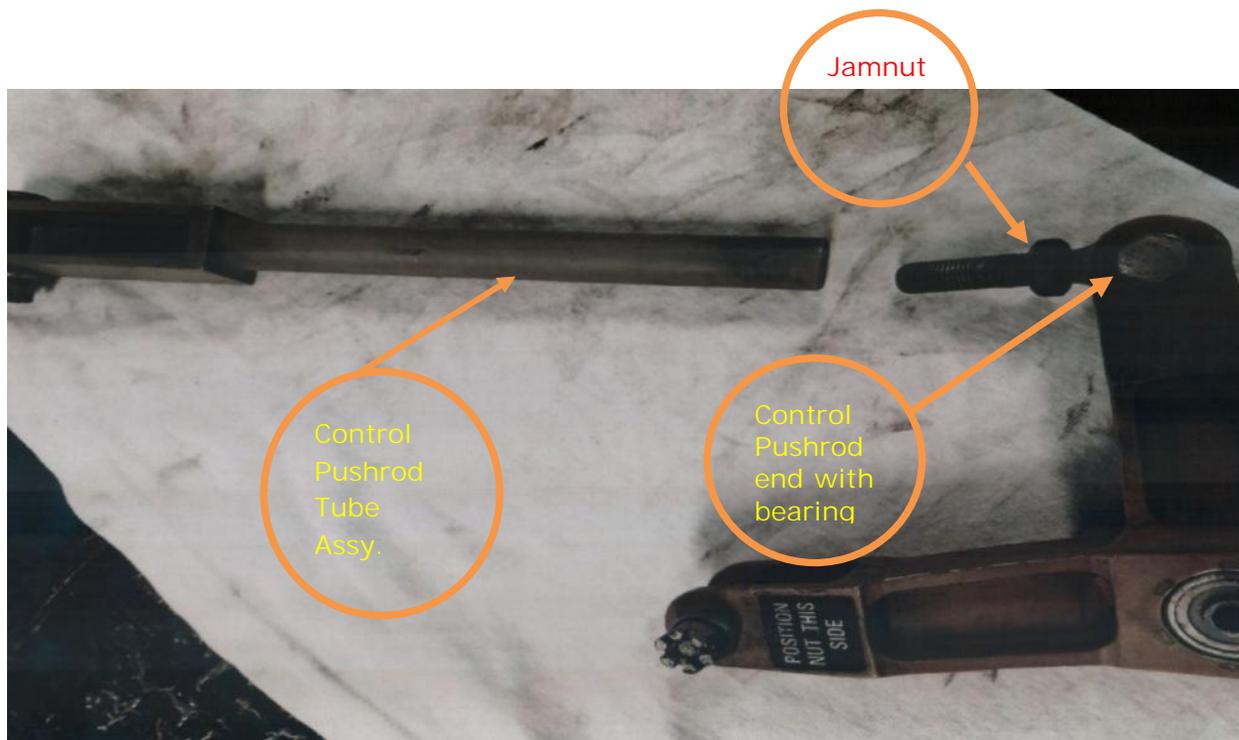
Fig. 9 The Control rod separated from the Bearing end and Jamnut

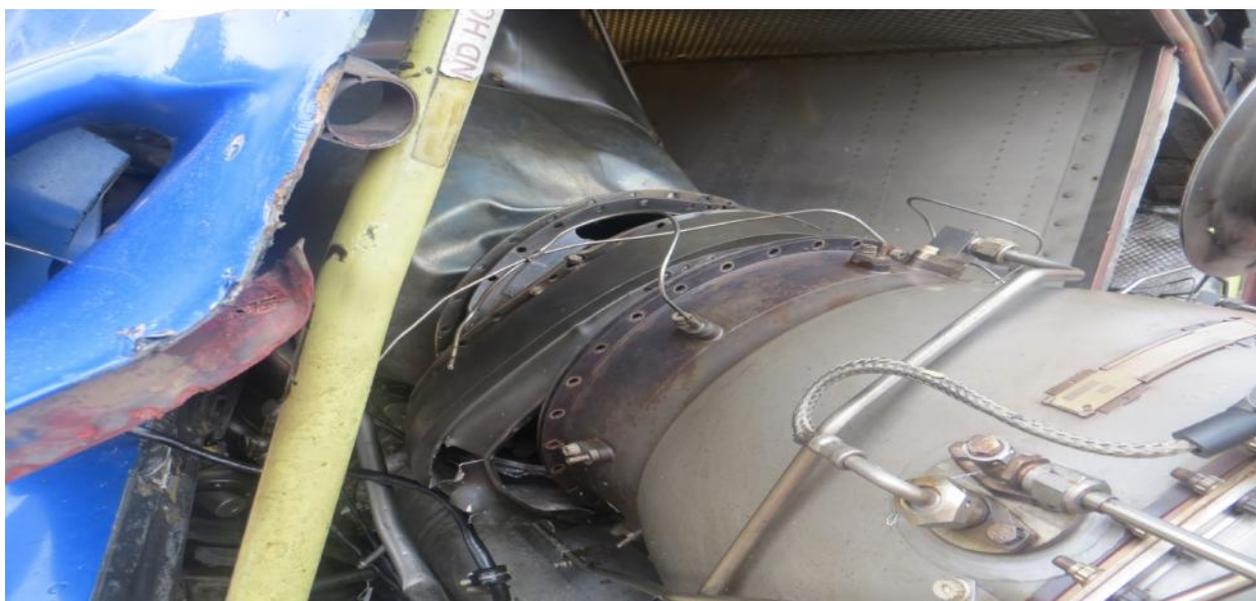
Field/Crash site examination of No.2 Engine revealed damage associated with uncontainment failure of internal components. The engines have been sent to the manufacturer in France. See Fig. 10 of the engine below.

Fig. 10 Engine No. 2 suffered an uncontained failure.

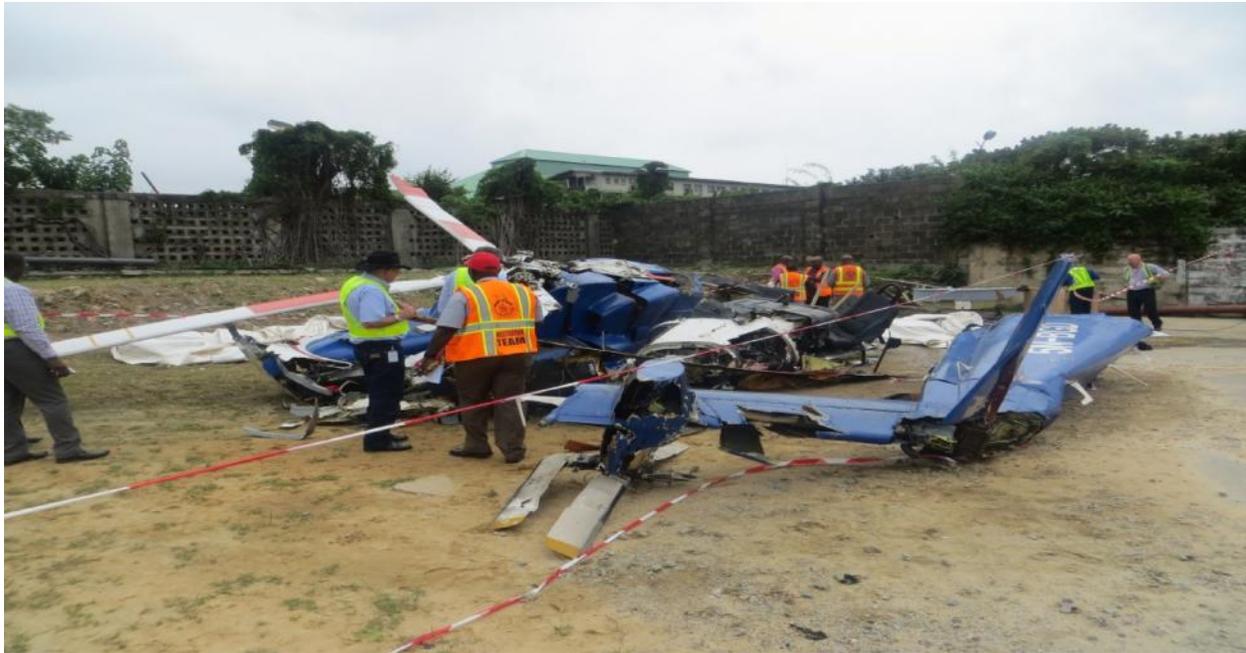
Photo 1. The helicopter recovered wreckage
